Manhole Inspection Summary

Manhole # S17M__008MH

Location Address: **2401 ashton-frederick shopping center** Cross Street: **s catherine**

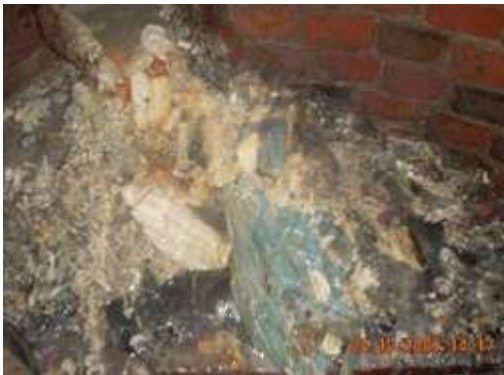
Defect 3

Bench ☒ Exists Material: **Brick** ☐ Parged
Condition: ☐ Sound ☐ Cracked ☐ Root Intrusion ☐ Deteriorated ☐ Leaks ☒ **Debris**

debris on bench

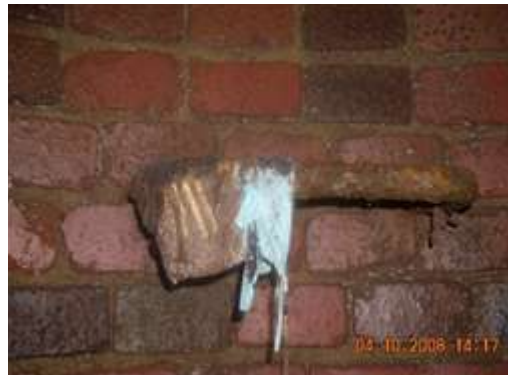
Defect 2

Surcharge ☒ **Evidence Of Surcharge** Depth: **8** (ft.) ☐ Active Surcharge Present

surcharge evidence

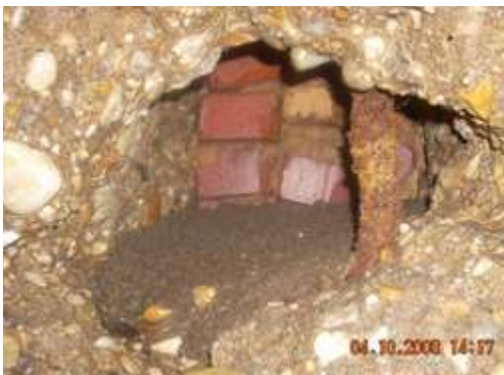
Defect 1

Barrel Material: **Brick and Concrete** ☐ Parged
Shape: **Circular** Diameter: **48** (in.) Length: **0** (in.)
Condition: ☐ Sound ☐ Cracked ☐ Root Intrusion ☐ Loose Brick ☒ **Deteriorated**
Infiltration: ☒ None ☐ Joint ☐ Cracks ☐ Mortar ☐ Roots ☐ Wall

hole in barrel wall

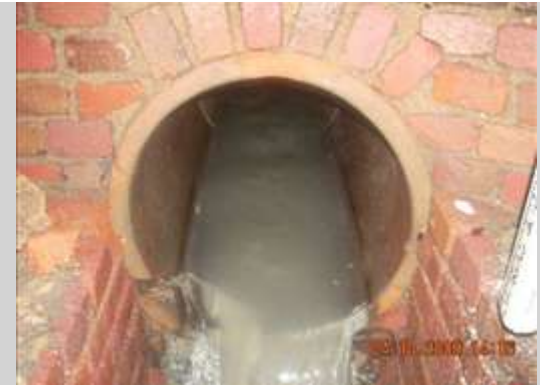
6 O'Clock Inflow

Infiltration: **Evidence** Pipe Seal Cond: **Broken**

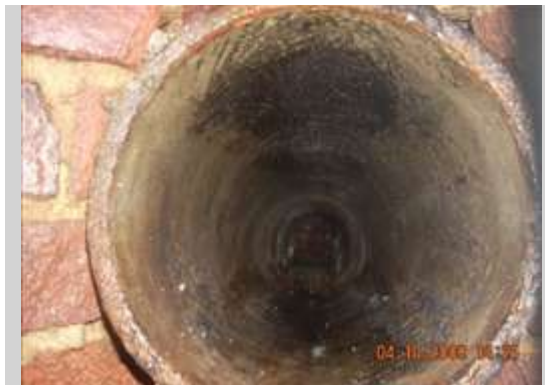
9 O'Clock Inflow

Deposits: ☐ None ☐ Mud ☒ Sludge ☐ Debris ☐ Grease

Silt Depth: **4** (in.) Deposits Extent: **Medium**

Infiltration: **None** Pipe Seal Cond: **Broken**

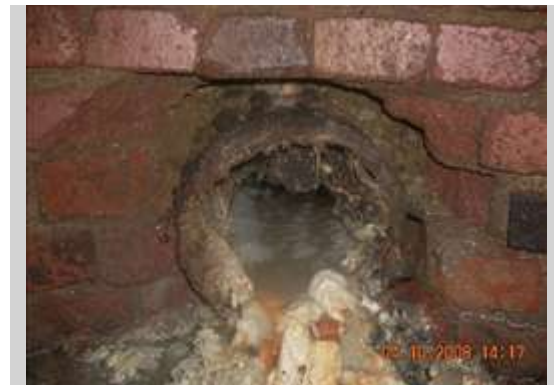
Pipe In @ 3 O'Clock

Drop Condition: **Partly Clogged**
